Pump Seal Failure - Case Study

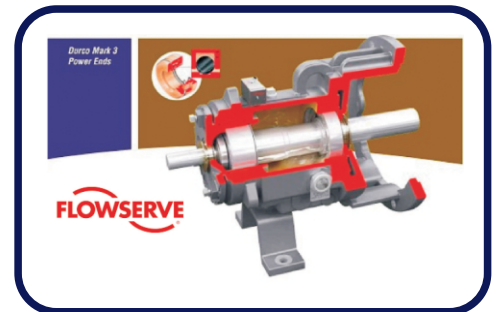
Flexachem examined all seals and pumps and assessed the situation. Flexachem evaluated all pumps on site with regards to; ■ Operation, ■ Condition, ■ Alignment ■ Age and then delivered a comprehensive report on the findings.

Typically, "10% of pump failures are due to normal mechanical seal or bearing wear". Flexachem installed a vibrational monitoring tool (IPS Beacon) on all "bad actor" pumps, ie. Pumps with high seal failure. The IPS Beacon has a take away memory; and from the analysis of data acquired from the IPS Beacon the client had a cost-effective means of early notification of adverse operating conditions. This allowed them to implement corrective actions so that Mean Time Between Failure was increased. Thus the IPS Beacon extended the lifecycle of the pumps.

Flexachem installed a Flowserve ISC2 Mechanical Seal. The ISC2 can tolerate dry running for a limited time with its exclusive thermal management technology. The advanced seal design features deliver superior rotating equipment reliability. The sleeve acts as a heat sink, lowering seal face operating temperatures and transforming cavitation and dry running "bad actors" into highly reliable installations. The ISC2 Mechanical Seal ensured continuous up-time.

Pumps over a certain age and profile condition were ear-marked for phased replacement with a Durco Mark 3 Power End. The Power End is the "Heart" of the pump which consists of the shaft and bearing design. Durco offer the largest shaft and bearing components available in the standard ANSI Pumps. The new Power End gave the existing pumps significantly extended life expectancy. Where the pumps were deemed high risk of continuous failure, owing to their condition, they were sized and replaced with Durco Mark 3 pumps.
